REMOVAL REPORT
FOR
DIAZ INTERMEDIATES CORPORATION SITE
301 WYANOKE ROAD
WEST MEMPHIS, CRITTENDEN COUNTY, ARKANSAS

**REMOVAL ASSESSMENT REPORT
FOR
DIAZ INTERMEDIATES CORPORATION SITE

301 WYANOKE ROAD
WEST MEMPHIS, CRITTENDEN COUNTY, ARKANSAS**

Date Prepared:
October 27, 2008

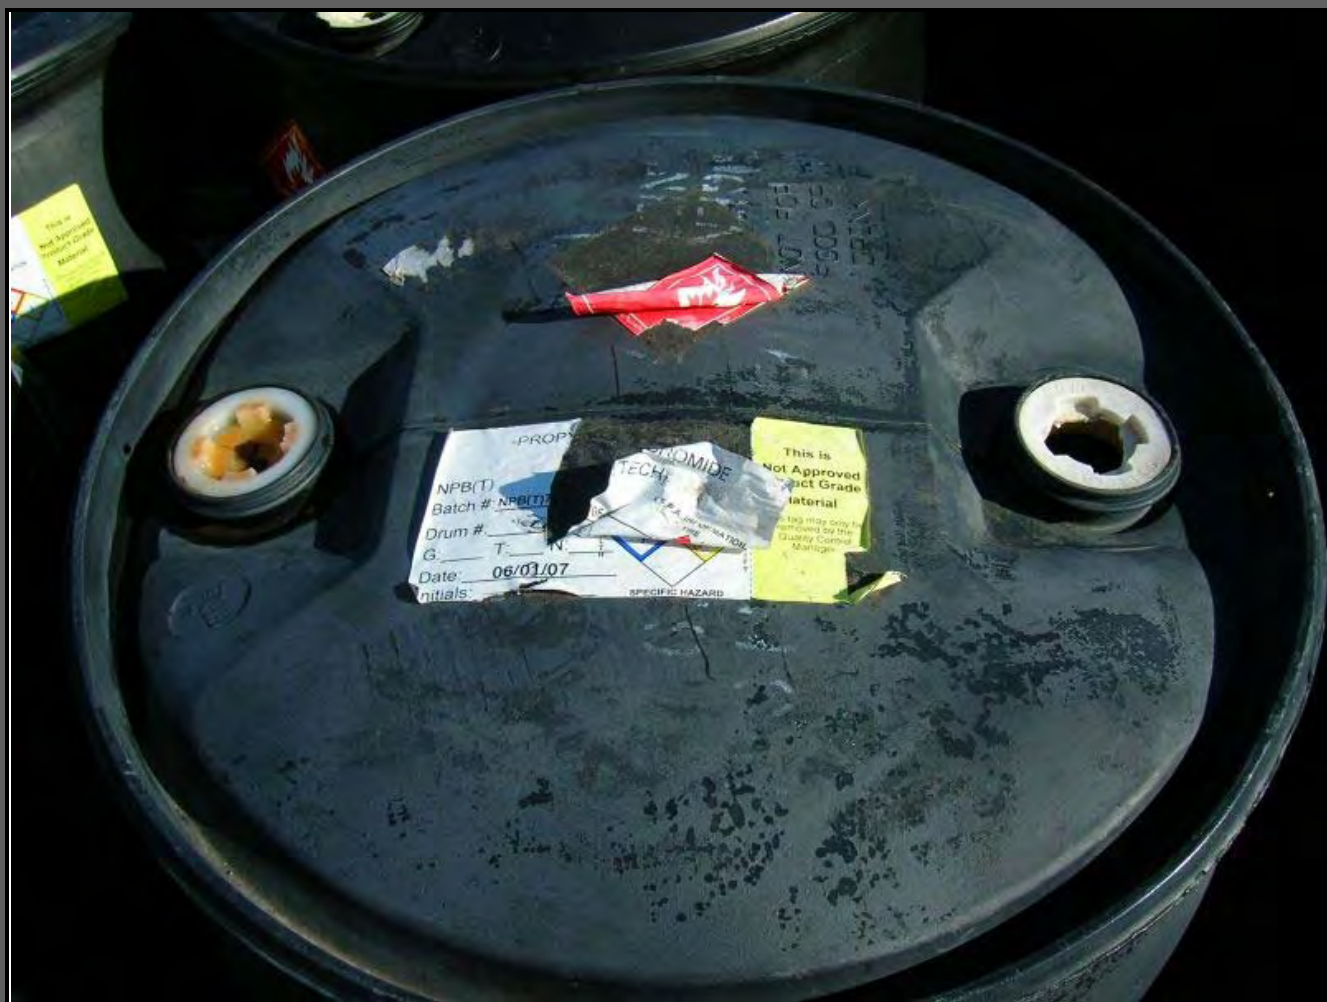
Logbook Photo #	016
US EPA ID / Task Order Number	ARR000005843 / TO-0001-08-01-01
Site	Diaz Intermediates Corporation
Location Address	301 Wyanoke Road
City, State, ZIP code	West Memphis, Arkansas 72301
County	Crittenden
Direction/Orientation	Down
Date	01/09/08
Time	1326
Photographer	Troy Naquin, Dynamac START-3
Witness	Charles Fisher, EPA Region 6
Description: Broken plastic bungs on Propyl Bromide drum.

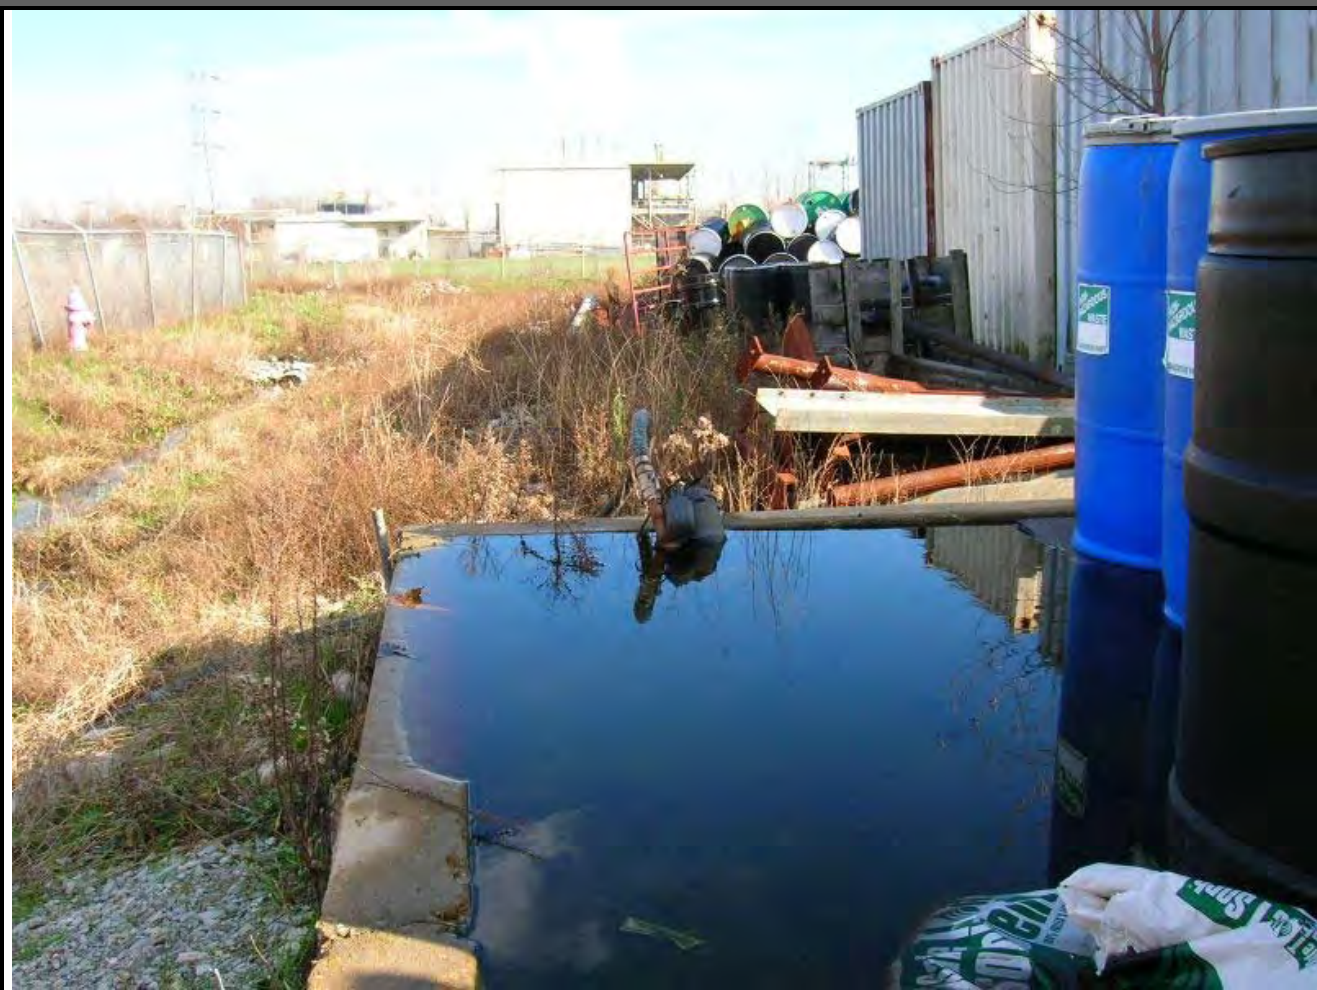
Logbook Photo #	017
US EPA ID / Task Order Number	ARR000005843 / TO-0001-08-01-01
Site	Diaz Intermediates Corporation
Location Address	301 Wyanoke Road
City, State, ZIP code	West Memphis, Arkansas 72301
County	Crittenden
Direction/Orientation	East
Date	01/09/08
Time	1338
Photographer	Troy Naquin, Dynamac START-3
Witness	Charles Fisher, EPA Region 6
Description: Another view of pooled storm water in Drum Pad containment area.

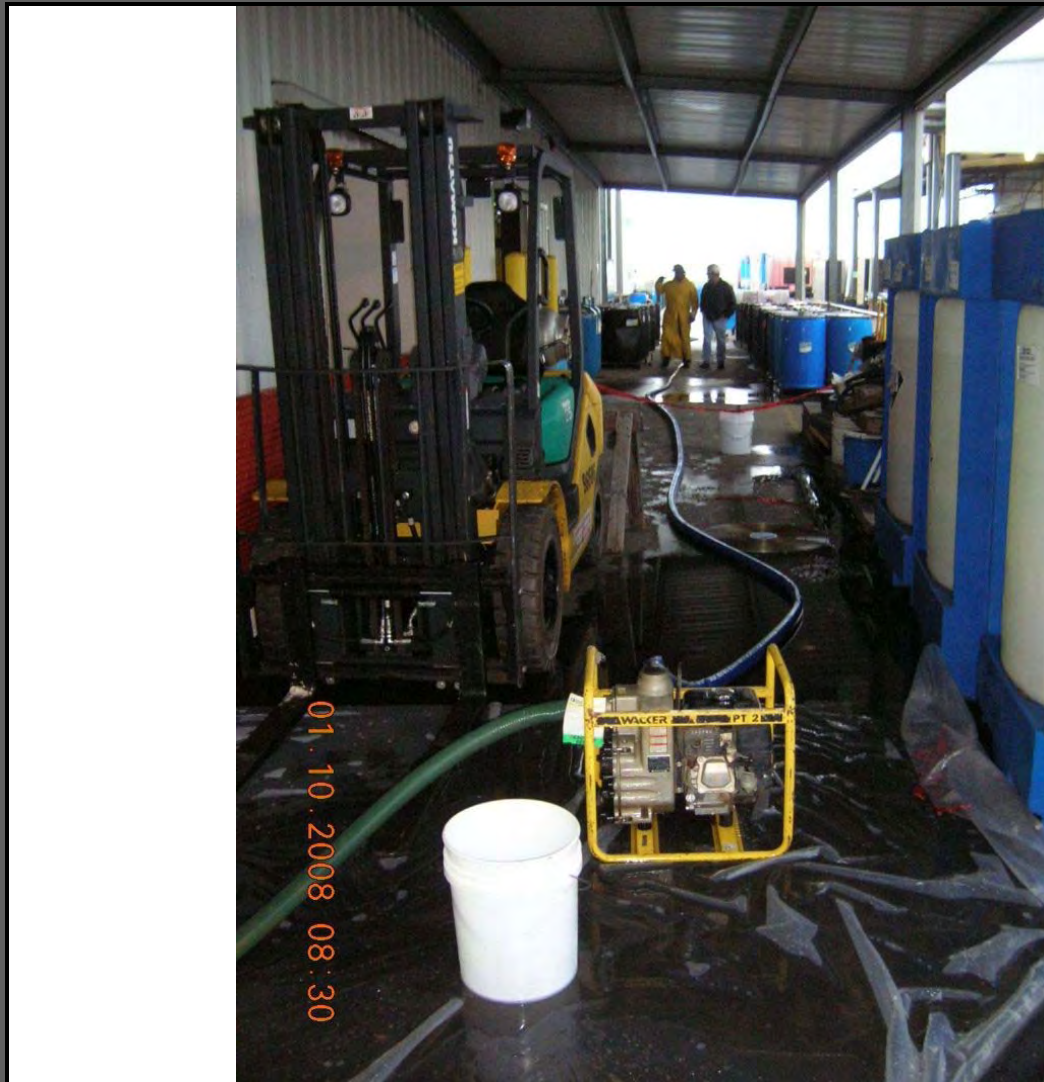
Logbook Photo #	018
US EPA ID / Task Order Number	ARR000005843 / TO-0001-08-01-01
Site	Diaz Intermediates Corporation
Location Address	301 Wyanoke Road
City, State, ZIP code	West Memphis, Arkansas 72301
County	Crittenden
Direction/Orientation	Northwest
Date	01/10/08
Time	0825
Photographer	Troy Naquin, Dynamac START-3
Witness	Charles Fisher, EPA Region 6
Description: ERRS pumping storm water out of Warehouse sump to Old Tank Farm secondary containment area.

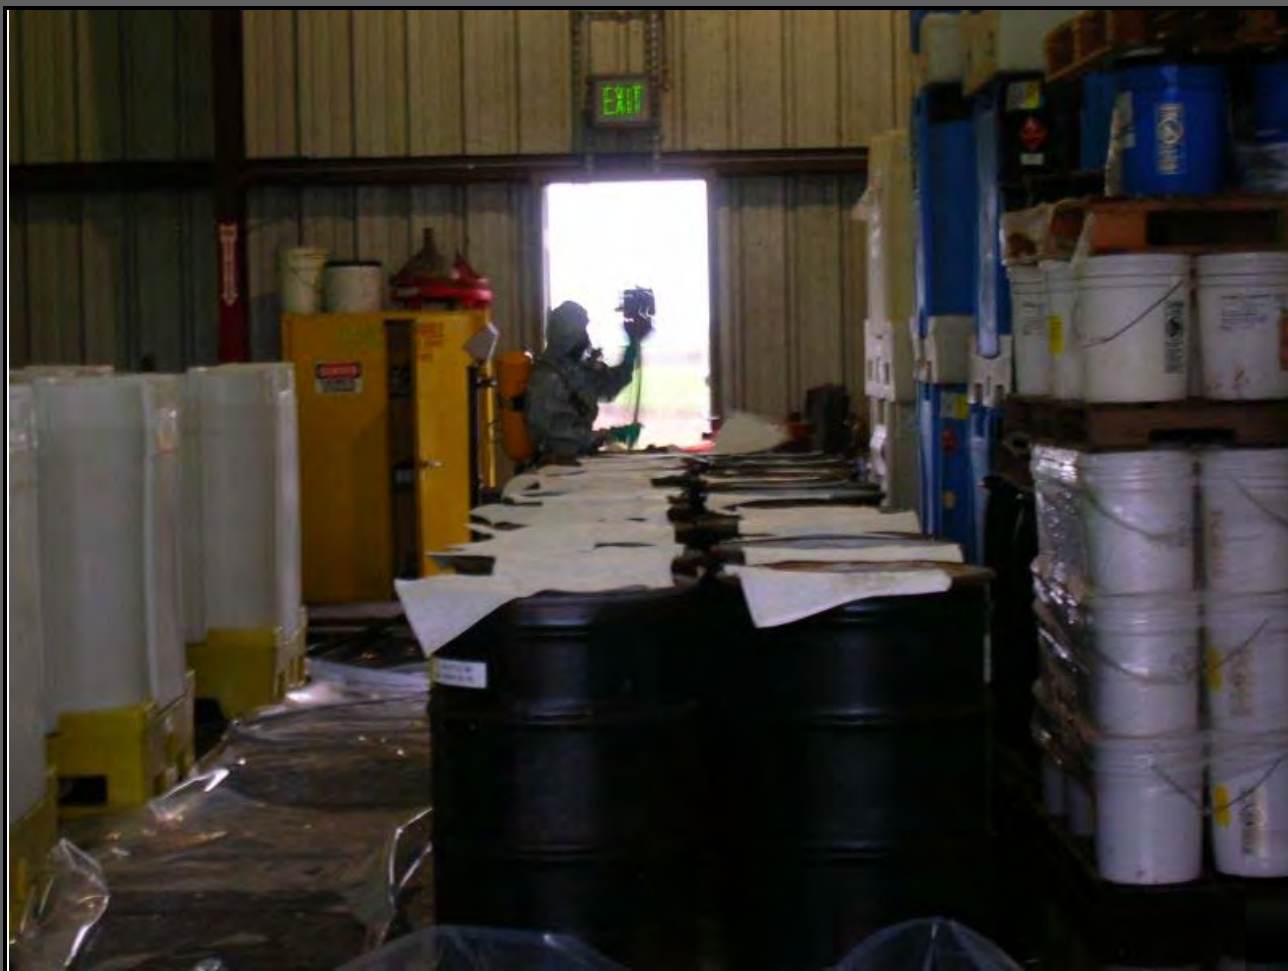
Logbook Photo #	020
US EPA ID / Task Order Number	ARR000005843 / TO-0001-08-01-01
Site	Diaz Intermediates Corporation
Location Address	301 Wyanoke Road
City, State, ZIP code	West Memphis, Arkansas 72301
County	Crittenden
Direction/Orientation	Northwest
Date	01/10/08
Time	0830
Photographer	Troy Naquin, Dynamac START-3
Witness	Charles Fisher, EPA Region 6
Description: Leaking drums of di-bromobenzene staged for transfer into tote tanks.

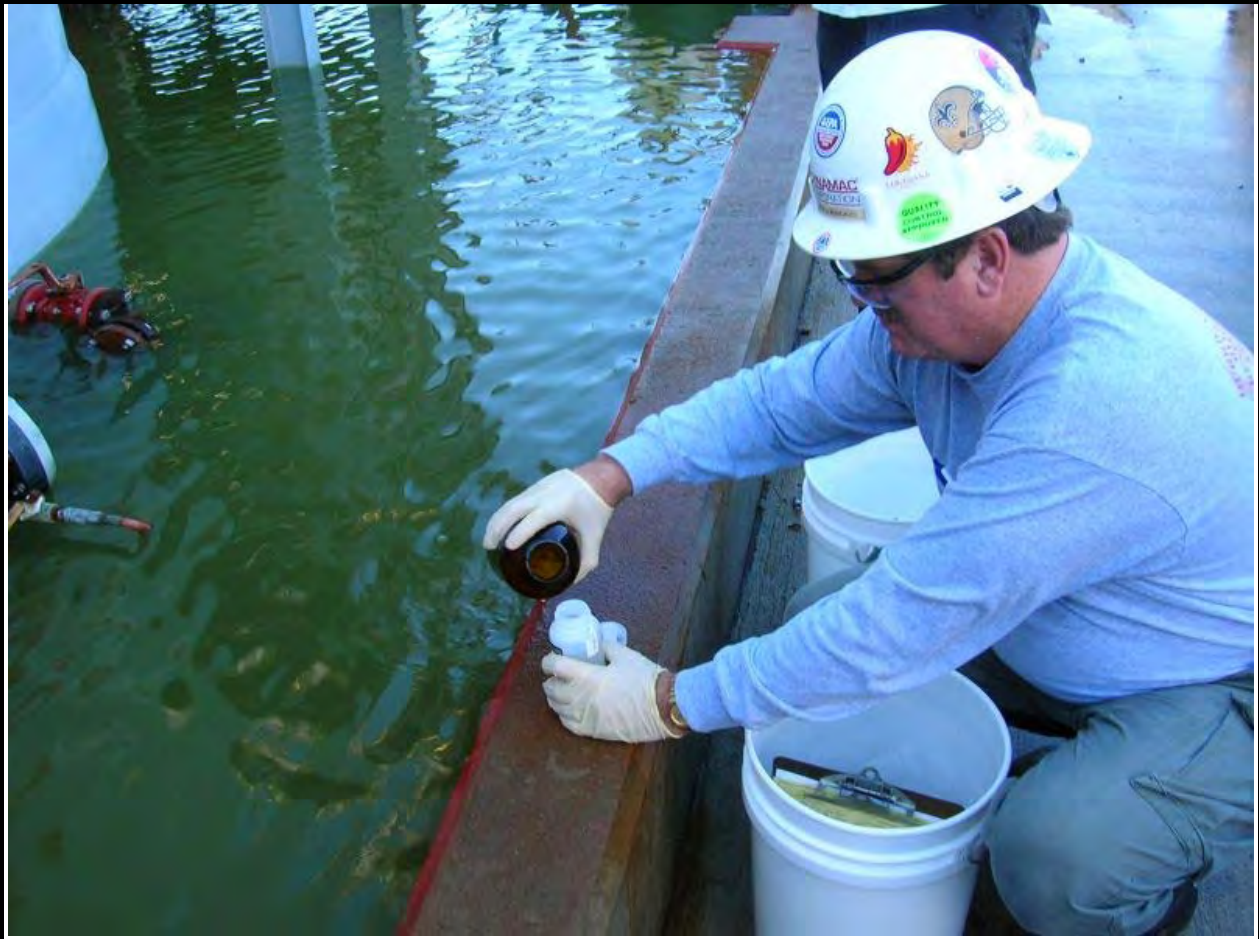
Logbook Photo #	023
US EPA ID / Task Order Number	ARR000005843 / TO-0001-08-01-01
Site	Diaz Intermediates Corporation
Location Address	301 Wyanoke Road
City, State, ZIP code	West Memphis, Arkansas 72301
County	Crittenden
Direction/Orientation	North-Northwest
Date	01/10/08
Time	1124
Photographer	Troy Naquin, Dynamac START-3
Witness	Charles Fisher, EPA Region 6
Description: Pooled storm water in New and Old Tank Farm secondary containment areas.

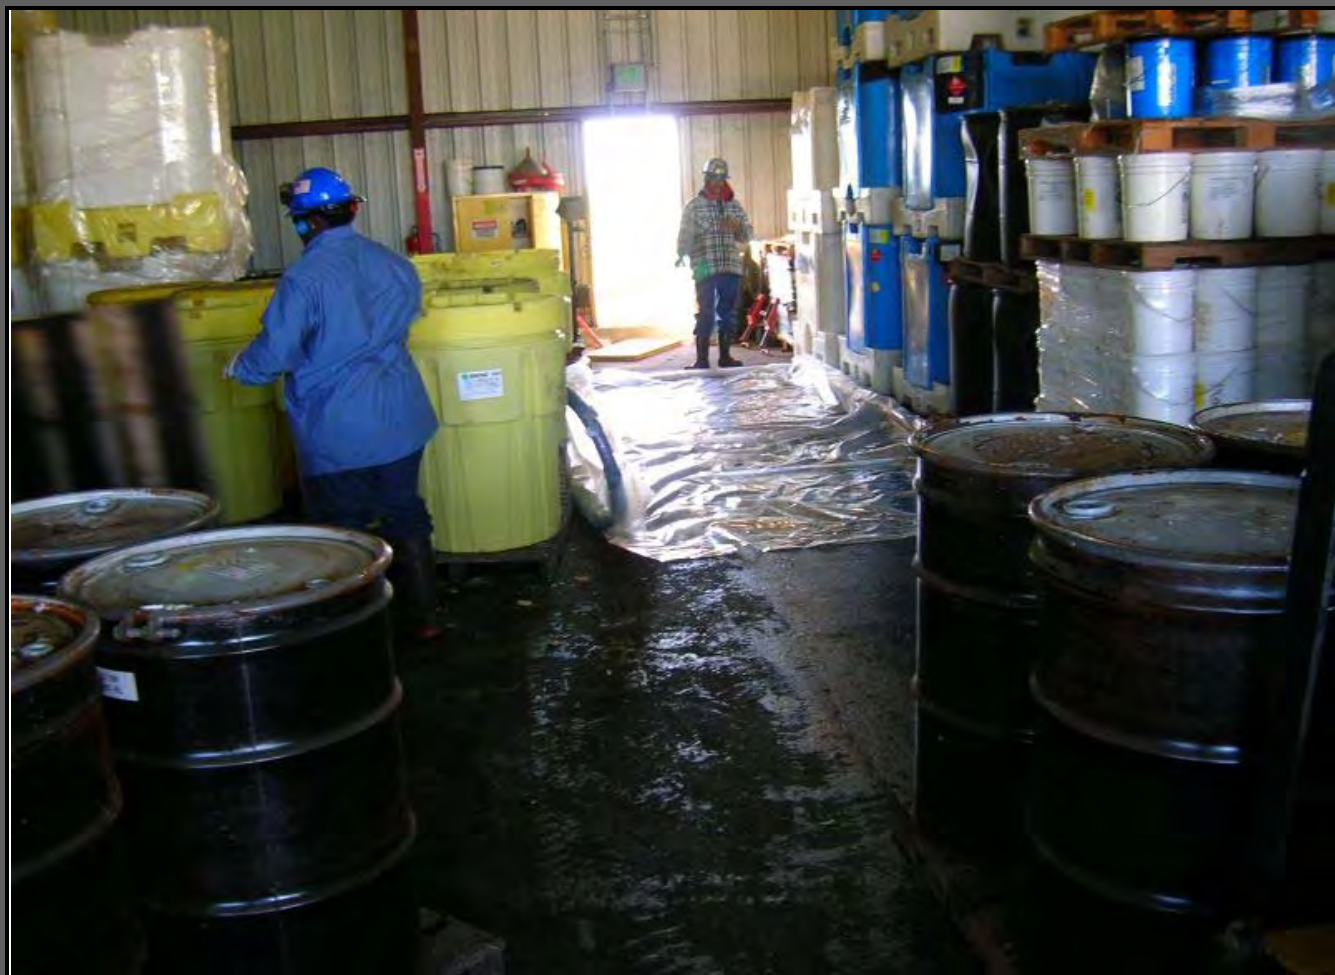
Logbook Photo #	032
US EPA ID / Task Order Number	ARR000005843 / TO-0001-08-01-01
Site	Diaz Intermediates Corporation
Location Address	301 Wyanoke Road
City, State, ZIP code	West Memphis, Arkansas 72301
County	Crittenden
Direction/Orientation	West
Date	01/11/08
Time	0901
Photographer	Troy Naquin, Dynamac START-3
Witness	Charles Fisher, EPA Region 6
Description:	ERRS transferring the contents of the di-bromobenzene drums into tote tanks.

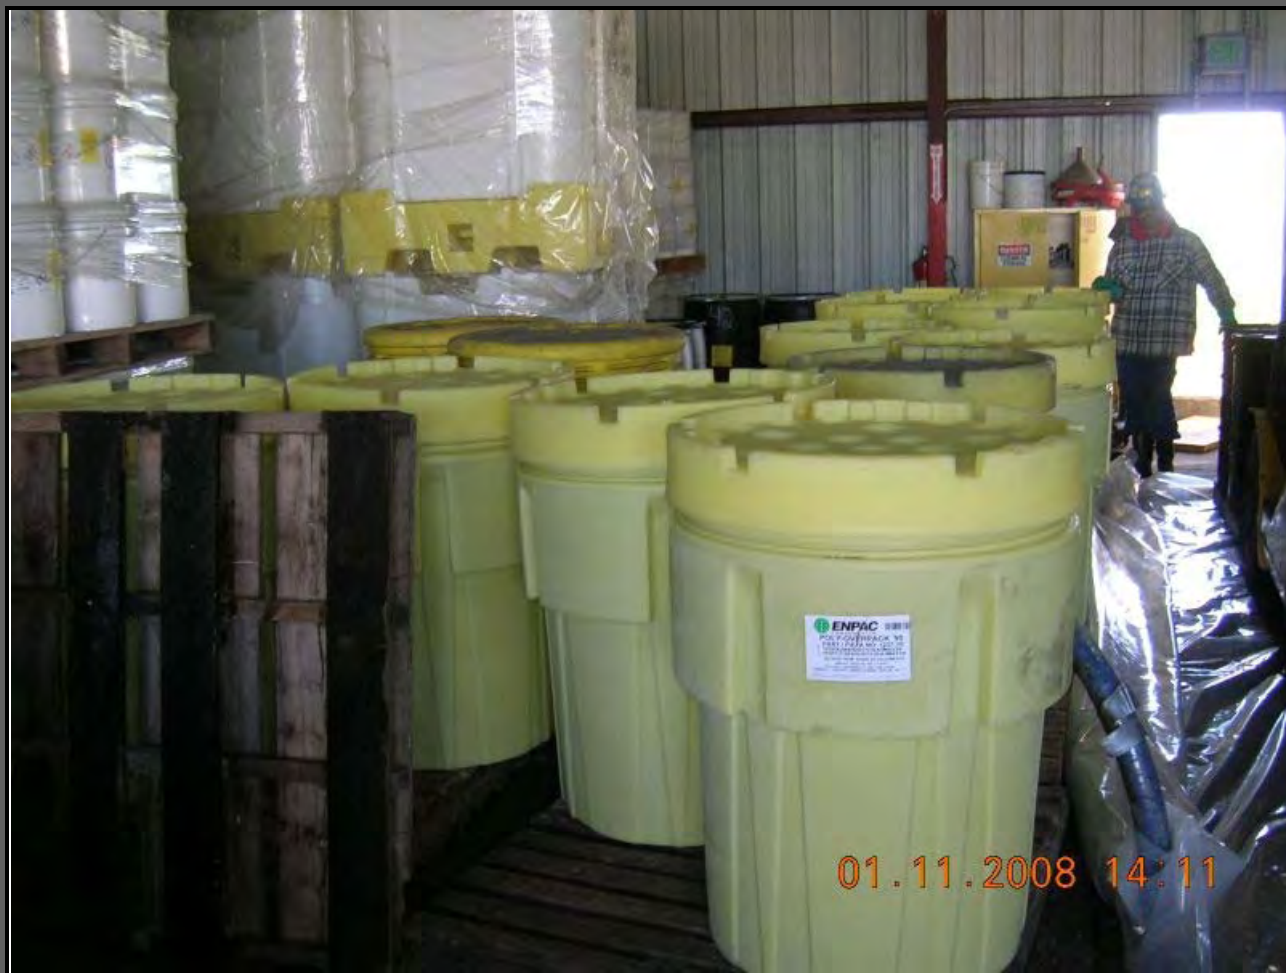
Logbook Photo #	034
US EPA ID / Task Order Number	ARR000005843 / TO-0001-08-01-01
Site	Diaz Intermediates Corporation
Location Address	301 Wyanoke Road
City, State, ZIP code	West Memphis, Arkansas 72301
County	Crittenden
Direction/Orientation	West
Date	01/11/08
Time	1411
Photographer	Troy Naquin, Dynamac START-3
Witness	Charles Fisher, EPA Region 6
Description: Thirteen over-pack drums containing di-bromobenzene sludge.

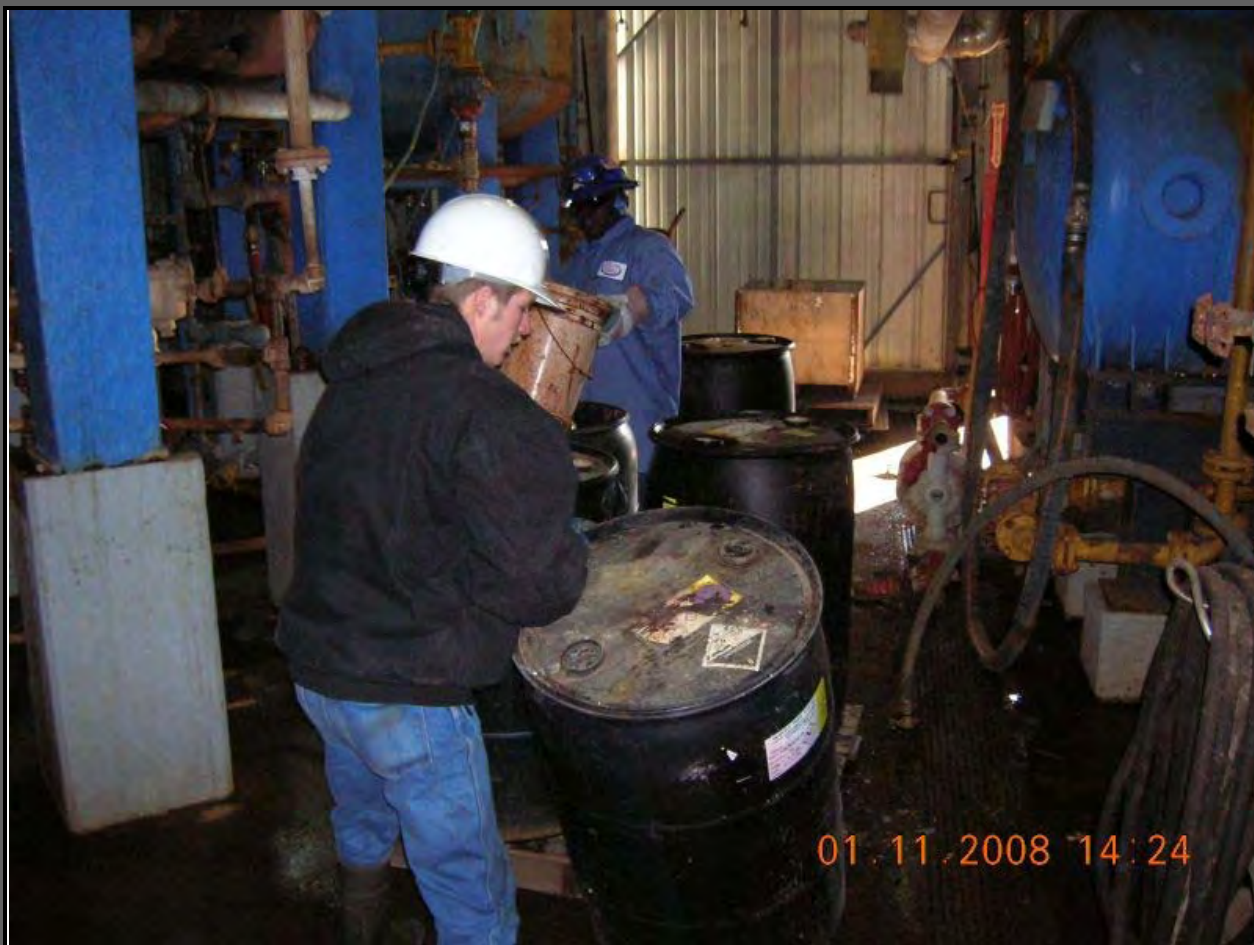
Logbook Photo #	035
US EPA ID / Task Order Number	ARR000005843 / TO-0001-08-01-01
Site	Diaz Intermediates Corporation
Location Address	301 Wyanoke Road
City, State, ZIP code	West Memphis, Arkansas 72301
County	Crittenden
Direction/Orientation	West
Date	01/11/08
Time	1411
Photographer	Troy Naquin, Dynamac START-3
Witness	Charles Fisher, EPA Region 6
Description:	Di-bromobenzene drums with sludge staged in the constructed containment area.

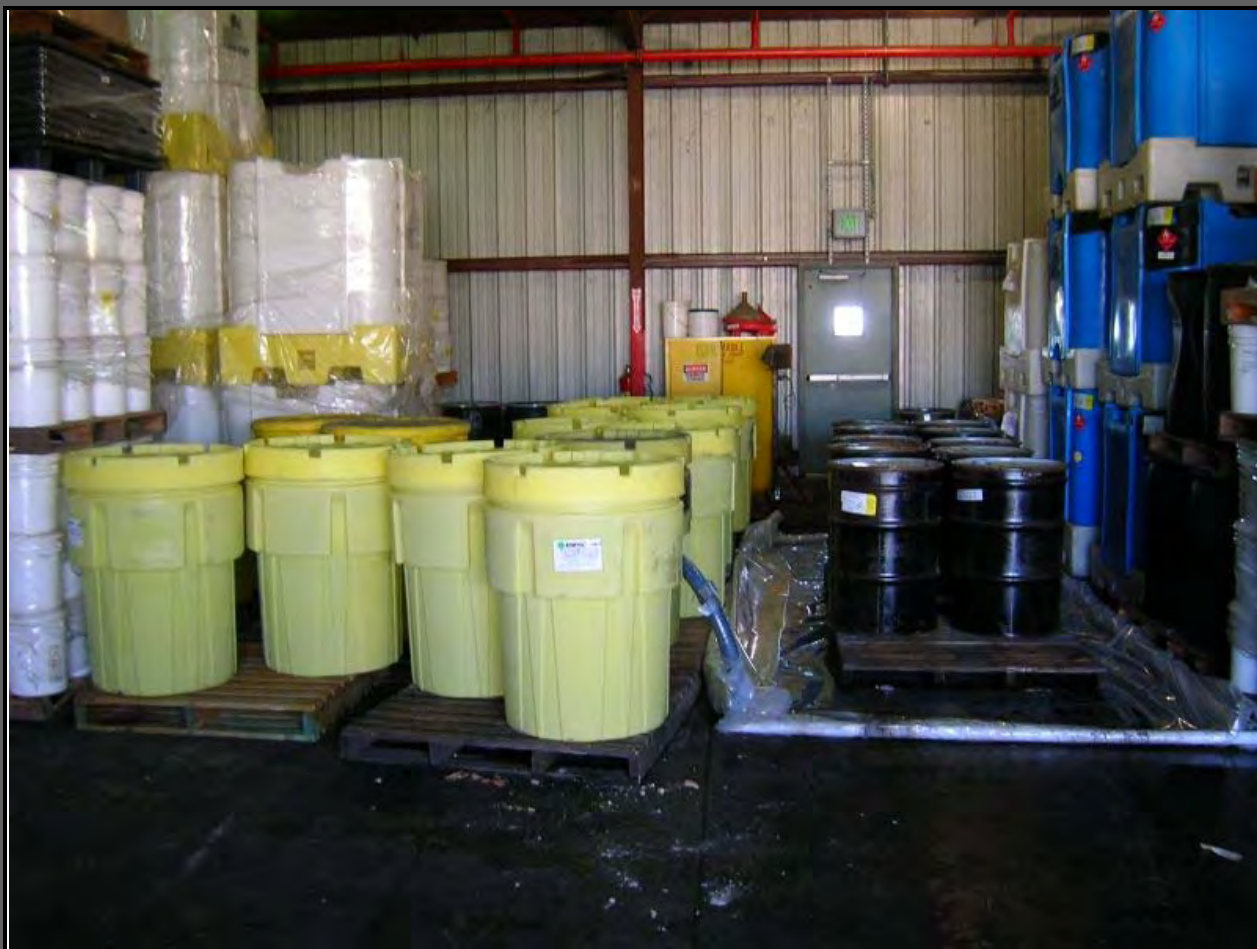
Logbook Photo #	036
US EPA ID / Task Order Number	ARR000005843 / TO-0001-08-01-01
Site	Diaz Intermediates Corporation
Location Address	301 Wyanoke Road
City, State, ZIP code	West Memphis, Arkansas 72301
County	Crittenden
Direction/Orientation	South
Date	01/11/08
Time	1424
Photographer	Troy Naquin, Dynamac START-3
Witness	Charles Fisher, EPA Region 6
Description: Elevating drums in Process Area off of floor.

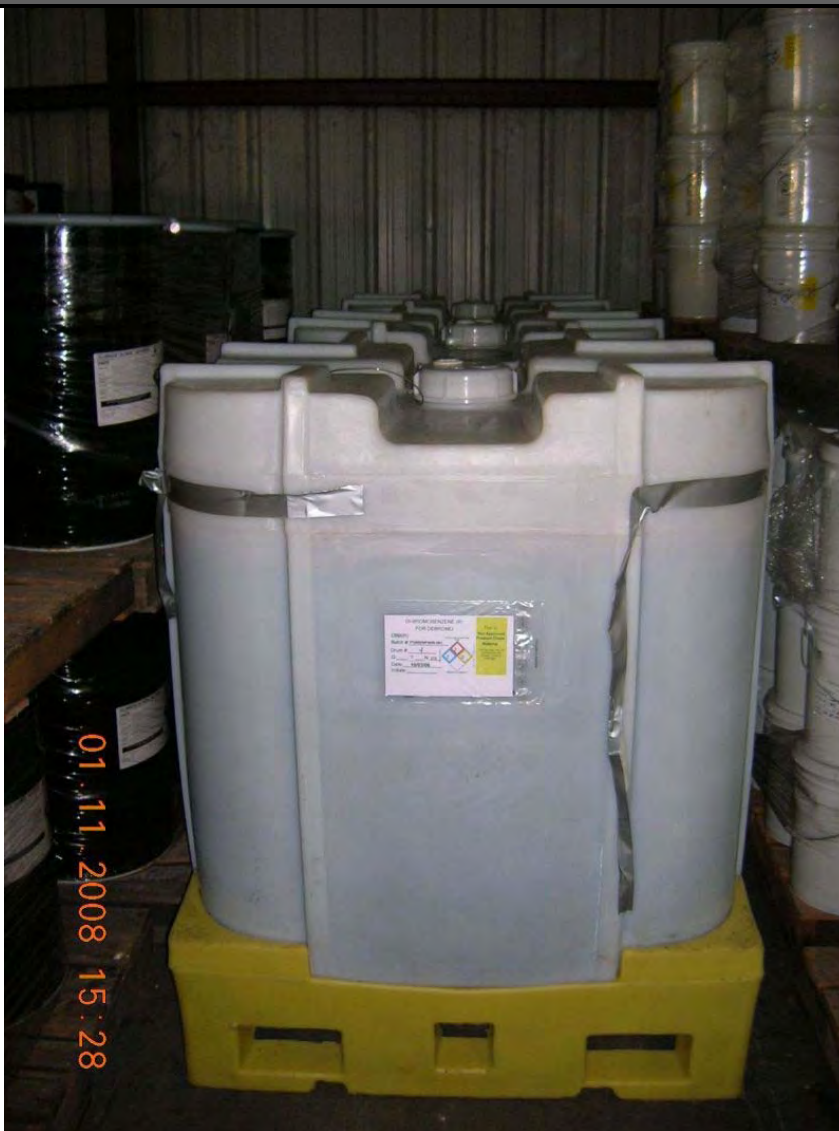
Logbook Photo #	037
US EPA ID / Task Order Number	ARR000005843 / TO-0001-08-01-01
Site	Diaz Intermediates Corporation
Location Address	301 Wyanoke Road
City, State, ZIP code	West Memphis, Arkansas 72301
County	Crittenden
Direction/Orientation	West
Date	01/11/08
Time	1525
Photographer	Troy Naquin, Dynamac START-3
Witness	Charles Fisher, EPA Region 6
Description: Di-bromobenzene drums stored in over-pack drums and staged on a constructed containment area in Warehouse.

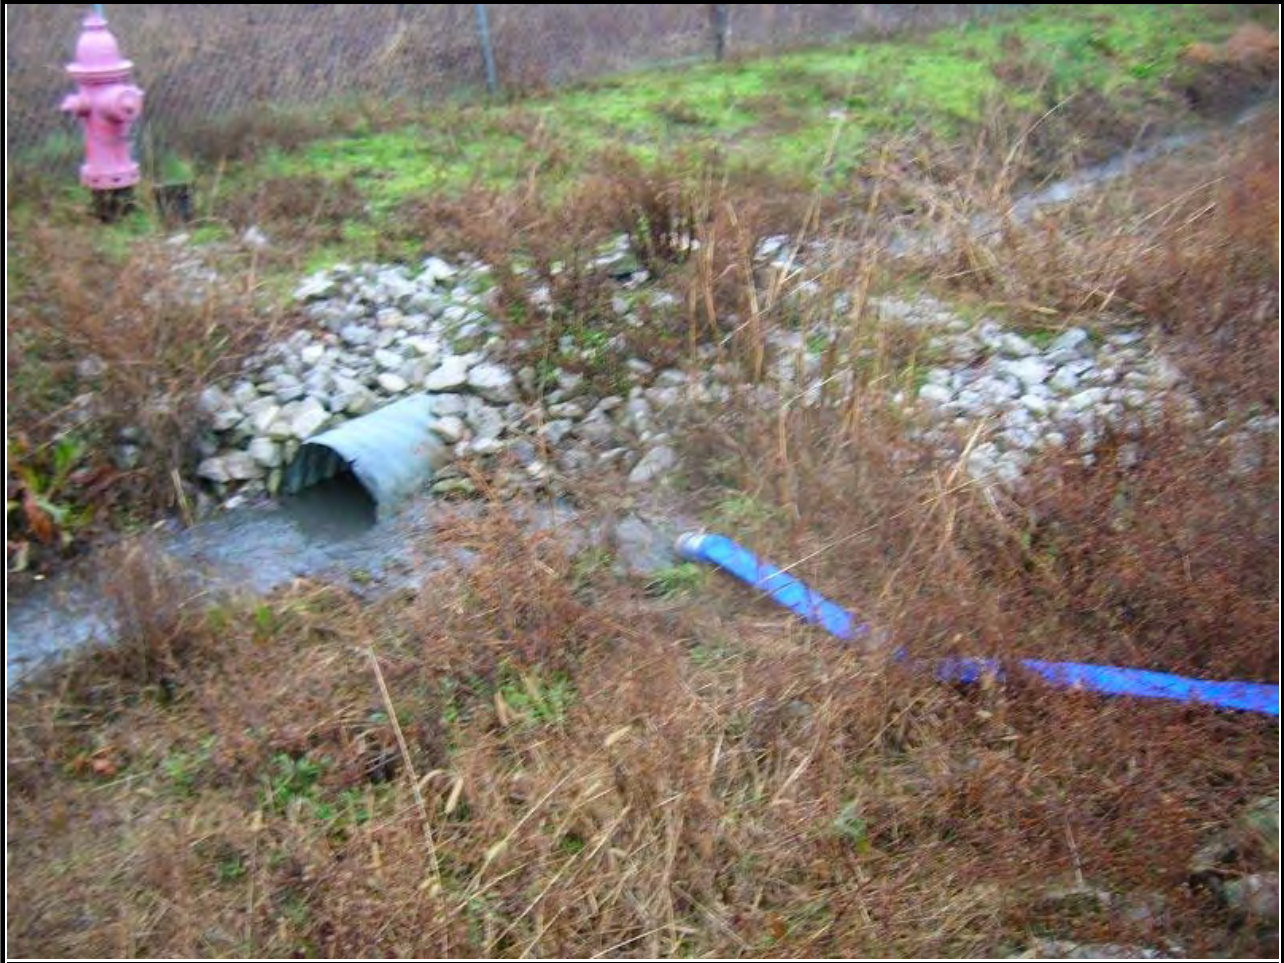
Logbook Photo #	039
US EPA ID / Task Order Number	ARR000005843 / TO-0001-08-01-01
Site	Diaz Intermediates Corporation
Location Address	301 Wyanoke Road
City, State, ZIP code	West Memphis, Arkansas 72301
County	Crittenden
Direction/Orientation	Southeast
Date	01/29/08
Time	0942
Photographer	Troy Naquin, Dynamac START-3
Witness	Charles Fisher, EPA Region 6
Description: Pumping of North Pad Sump Area into the storm water drainage pathway.

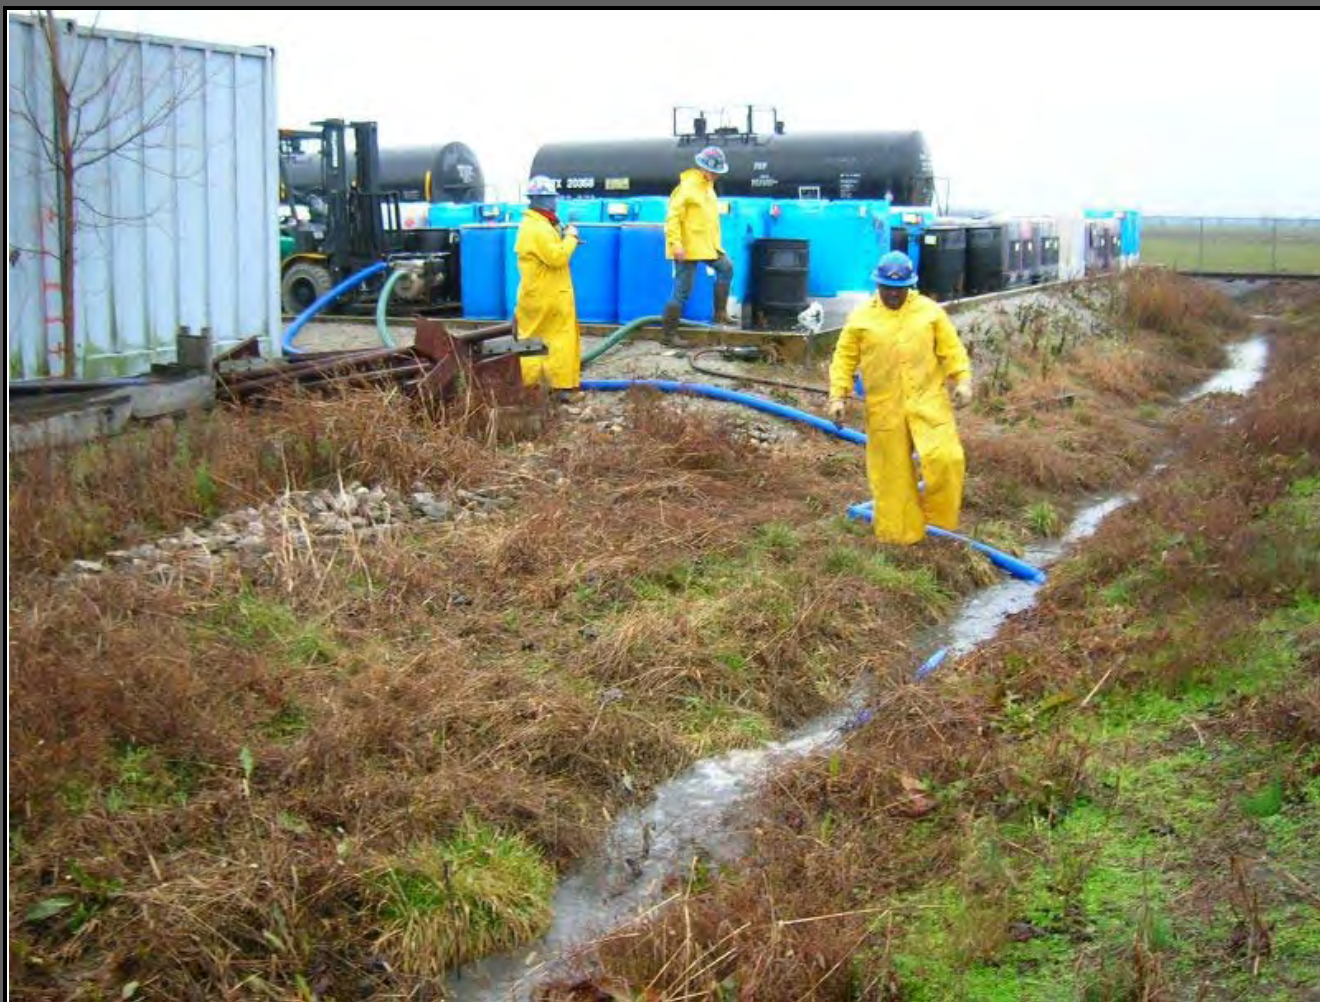
Logbook Photo #	040
US EPA ID / Task Order Number	ARR000005843 / TO-0001-08-01-01
Site	Diaz Intermediates Corporation
Location Address	301 Wyanoke Road
City, State, ZIP code	West Memphis, Arkansas 72301
County	Crittenden
Direction/Orientation	Northeast
Date	01/29/08
Time	0943
Photographer	Troy Naquin, Dynamac START-3
Witness	Charles Fisher, EPA Region 6
Description: Pumping of North Pad sump area into the storm water drainage pathway.

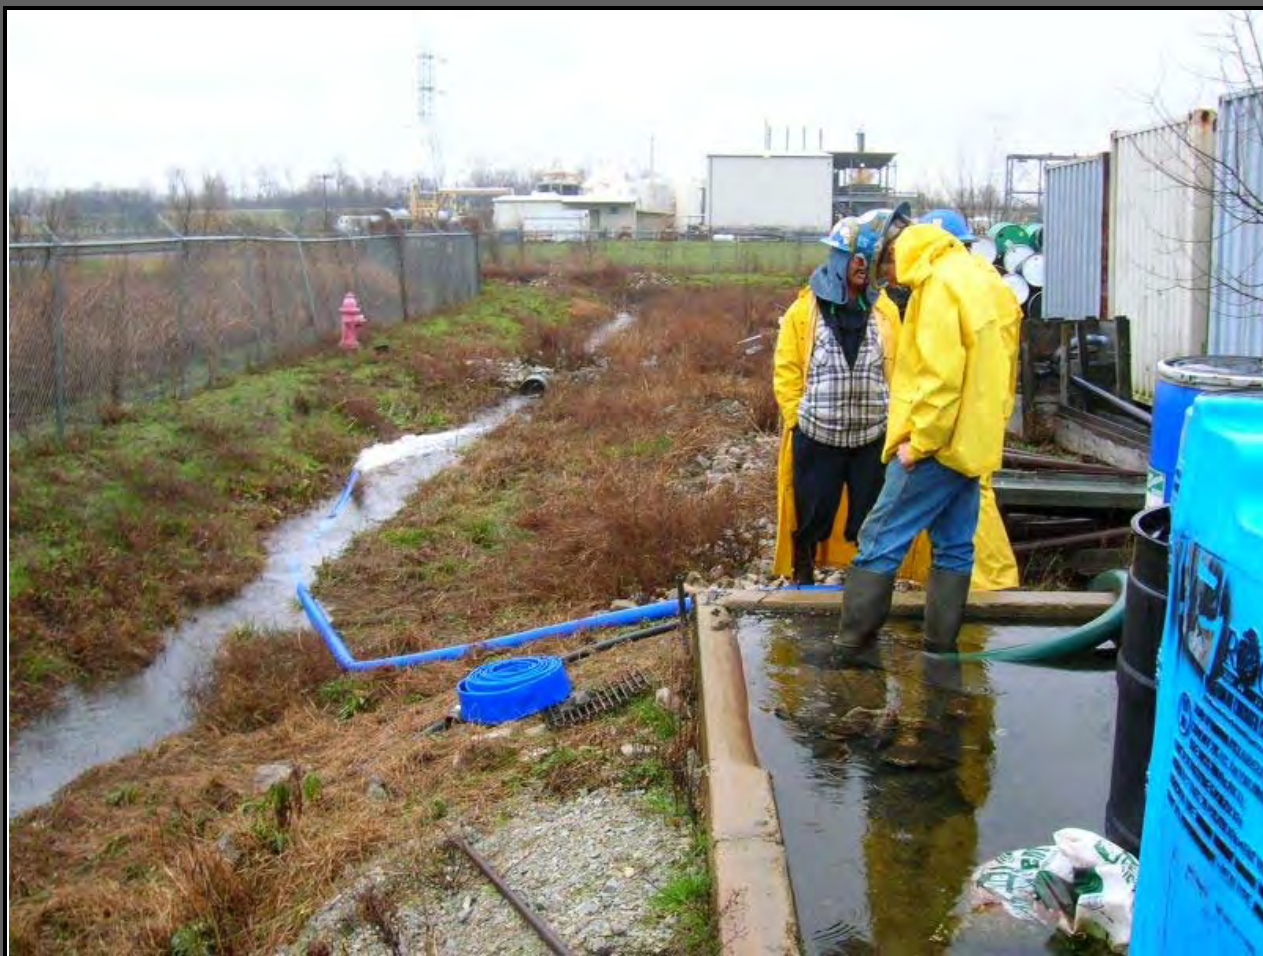
Logbook Photo #	041
US EPA ID / Task Order Number	ARR000005843 / TO-0001-08-01-01
Site	Diaz Intermediates Corporation
Location Address	301 Wyanoke Road
City, State, ZIP code	West Memphis, Arkansas 72301
County	Crittenden
Direction/Orientation	West-Southwest
Date	01/29/08
Time	0958
Photographer	Troy Naquin, Dynamac START-3
Witness	Charles Fisher, EPA Region 6
Description:	Pumping of Drum Pad containment area into the storm water drainage pathway.

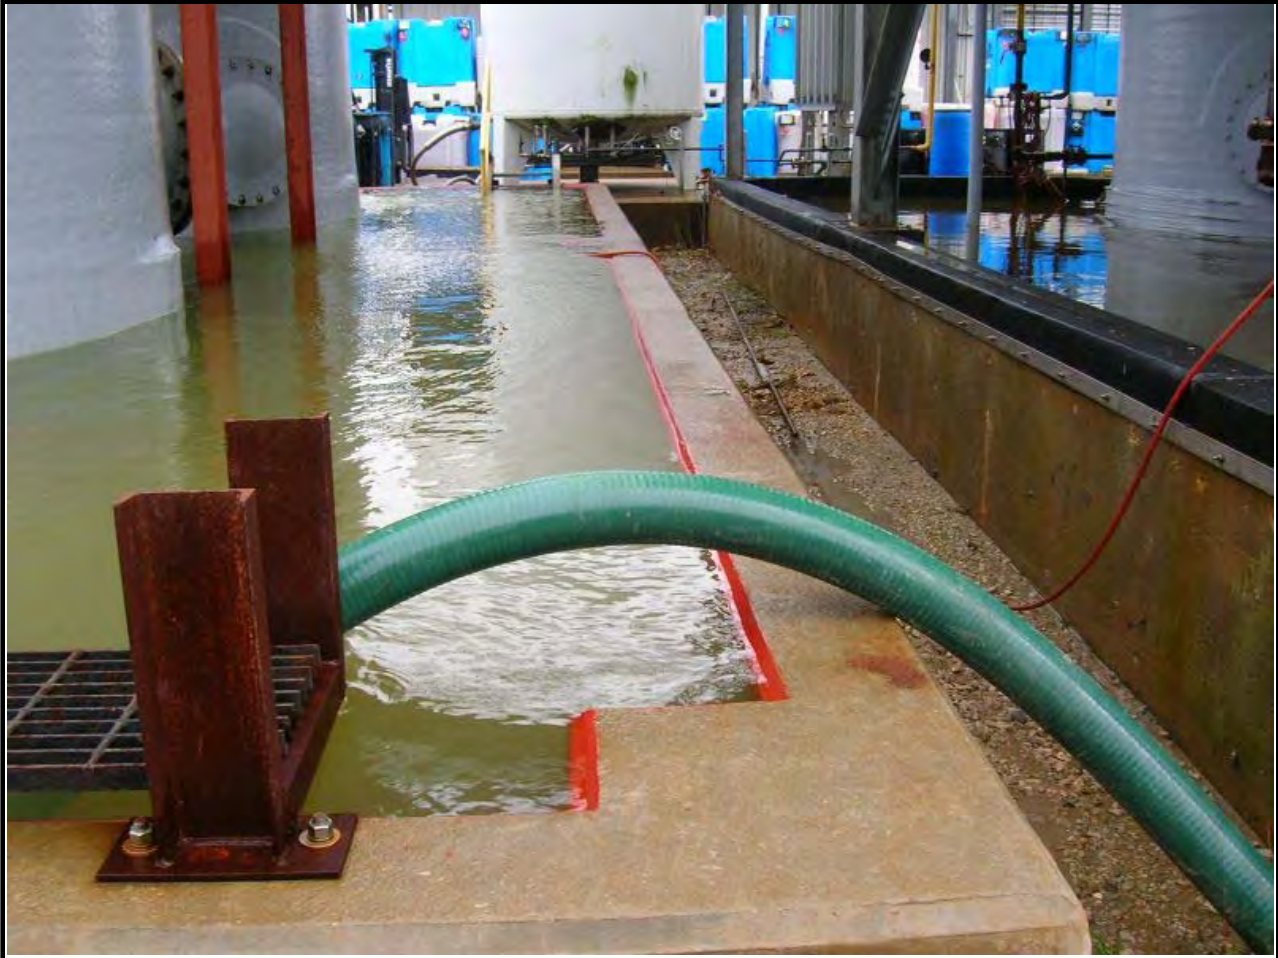
Logbook Photo #	042
US EPA ID / Task Order Number	ARR000005843 / TO-0001-08-01-01
Site	Diaz Intermediates Corporation
Location Address	301 Wyanoke Road
City, State, ZIP code	West Memphis, Arkansas 72301
County	Crittenden
Direction/Orientation	East
Date	01/29/08
Time	1004
Photographer	Troy Naquin, Dynamac START-3
Witness	Charles Fisher, EPA Region 6
Description: Pumping of Drum Pad containment area into the storm water drainage pathway.

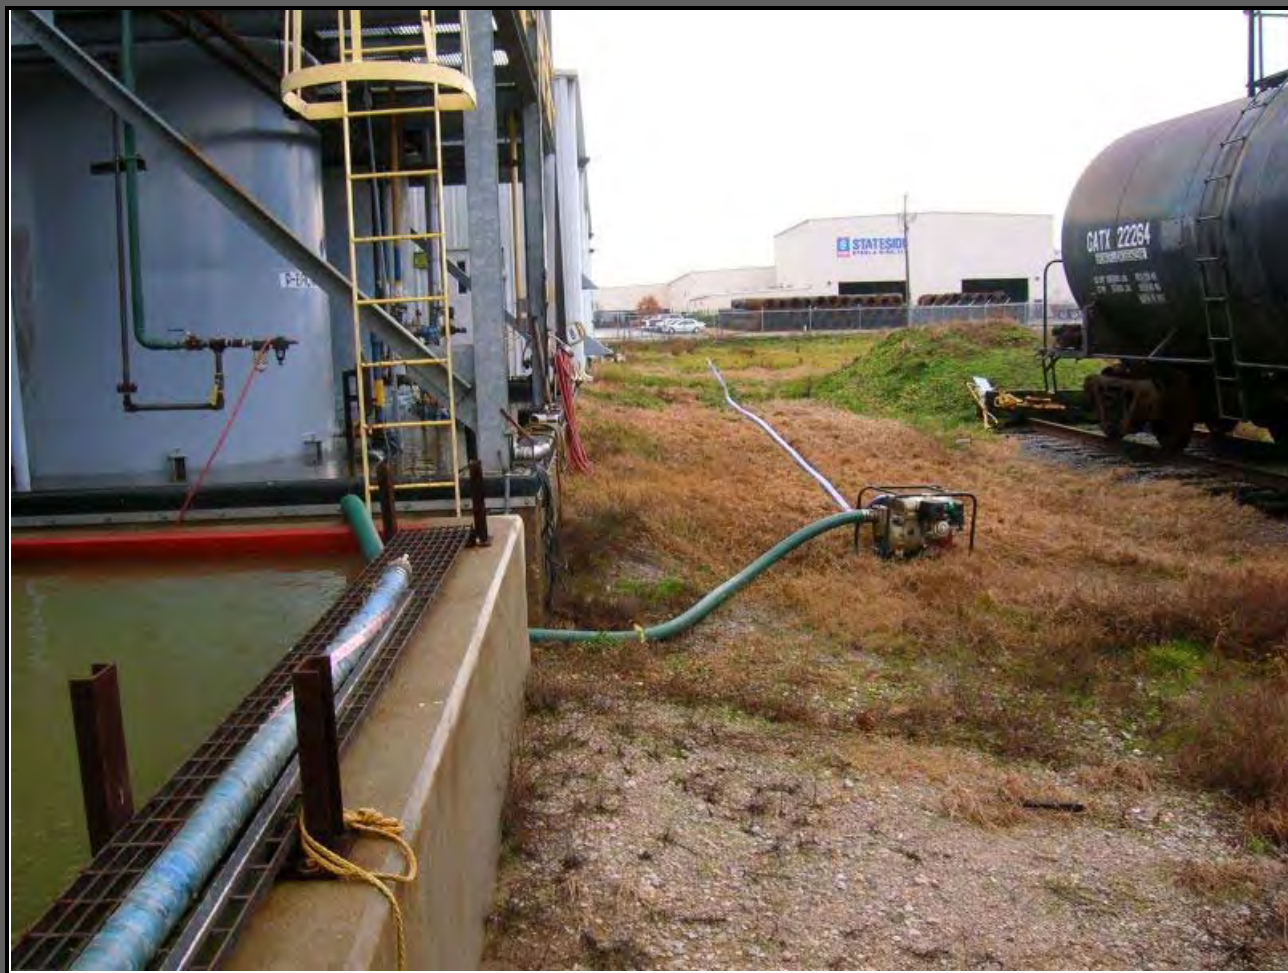
Logbook Photo #	043
US EPA ID / Task Order Number	ARR000005843 / TO-0001-08-01-01
Site	Diaz Intermediates Corporation
Location Address	301 Wyanoke Road
City, State, ZIP code	West Memphis, Arkansas 72301
County	Crittenden
Direction/Orientation	East
Date	01/29/08
Time	1346
Photographer	Troy Naquin, Dynamac START-3
Witness	Charles Fisher, EPA Region 6
Description: Pooled storm water in New Tank Farm secondary containment area prior to discharge.

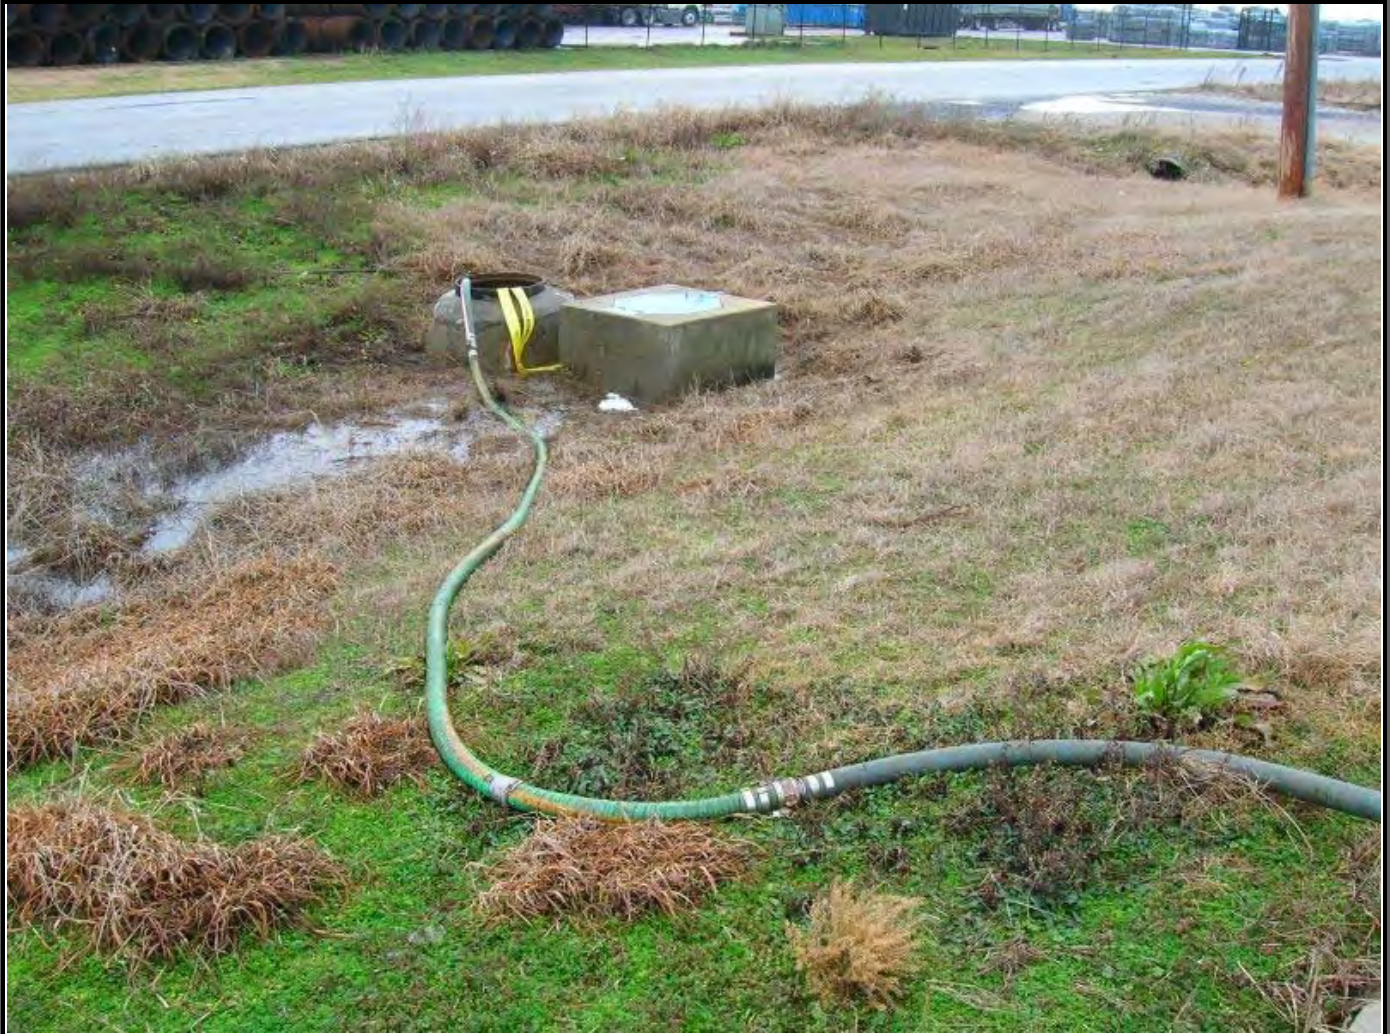
Logbook Photo #	044
US EPA ID / Task Order Number	ARR000005843 / TO-0001-08-01-01
Site	Diaz Intermediates Corporation
Location Address	301 Wyanoke Road
City, State, ZIP code	West Memphis, Arkansas 72301
County	Crittenden
Direction/Orientation	South
Date	01/29/08
Time	1417
Photographer	Troy Naquin, Dynamac START-3
Witness	Charles Fisher, EPA Region 6
Description: Pumping of pooled storm water in the New Tank Farm secondary containment area in to the sanitary sewer.

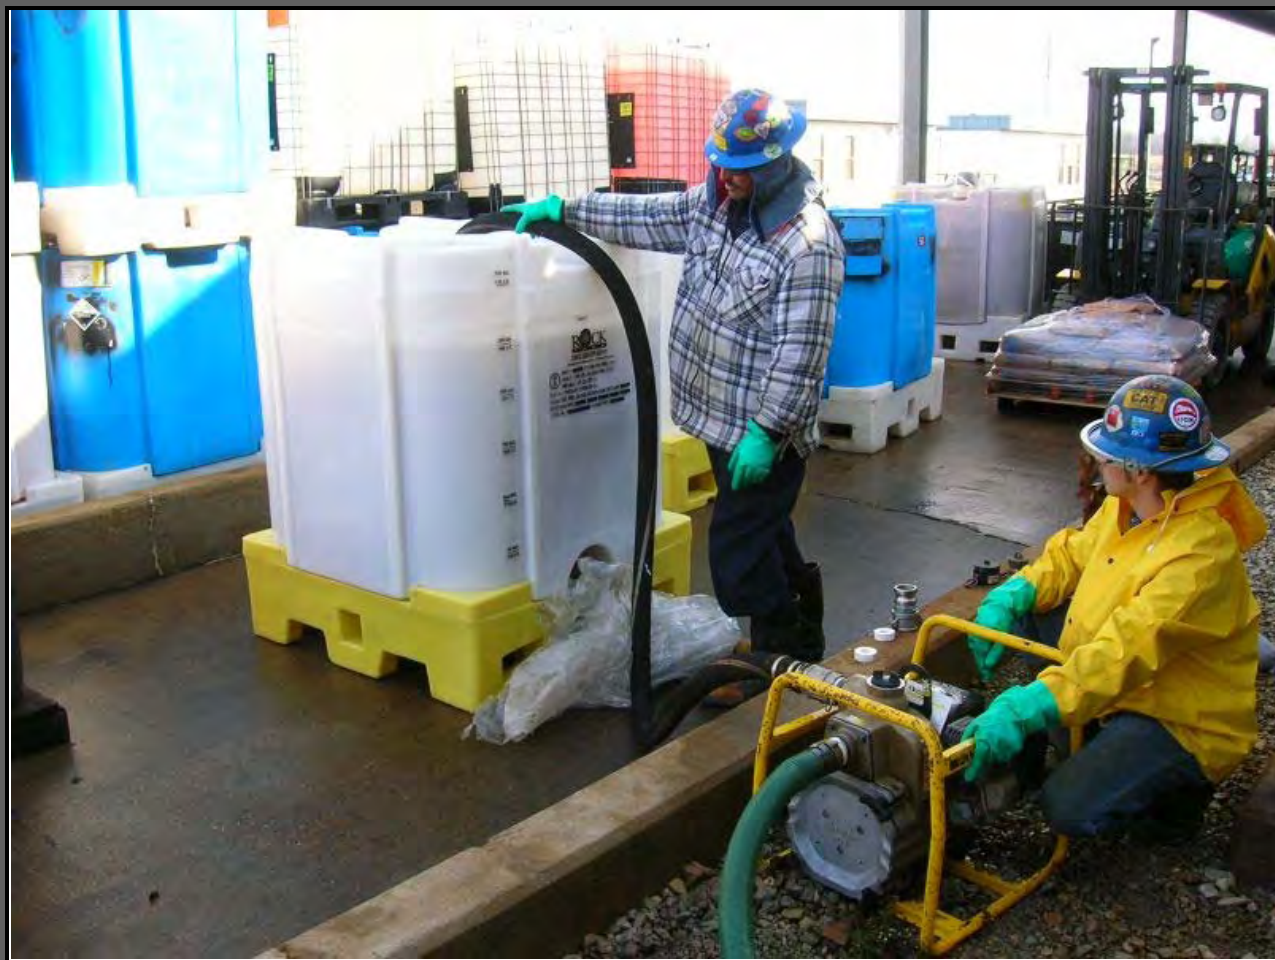
Logbook Photo #	048
US EPA ID / Task Order Number	ARR000005843 / TO-0001-08-01-01
Site	Diaz Intermediates Corporation
Location Address	301 Wyanoke Road
City, State, ZIP code	West Memphis, Arkansas 72301
County	Crittenden
Direction/Orientation	Southeast
Date	01/29/08
Time	1447
Photographer	Troy Naquin, Dynamac START-3
Witness	Charles Fisher, EPA Region 6
Description: Pumping storm water from the Old Tank Farm secondary containment area into tote tanks for mixing with caustic soda.
